**Flood Control Project Maintenance
Levee Inspections****LMA District Cover Sheet****Spring 2012 Levee Inspection Results****Reclamation District No. 2096 Wetherbee Lake**

Levee Inspection Report By Mile - Spring 2012

Reclamation District No. 2096 Wetherbee Lake

Waterway					Bank	Unit Miles	Inspection Start/End	Inspector	
Unit No. 01 San Joaquin River					Right	0.17	05/24/2012 05/24/2012	Max Khashchuk

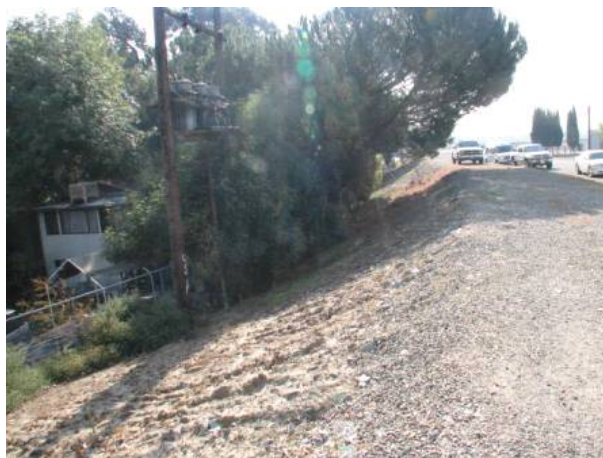
mkhashch_s_20120511_083.jpg

Levee Mile Report Line	4
Start Levee Mile	0.04
End Levee Mile	0.17
Location	Land Side
Category	Earthen Levee
Item	Encroachments

11/09/2011 Fence at toe of levee.

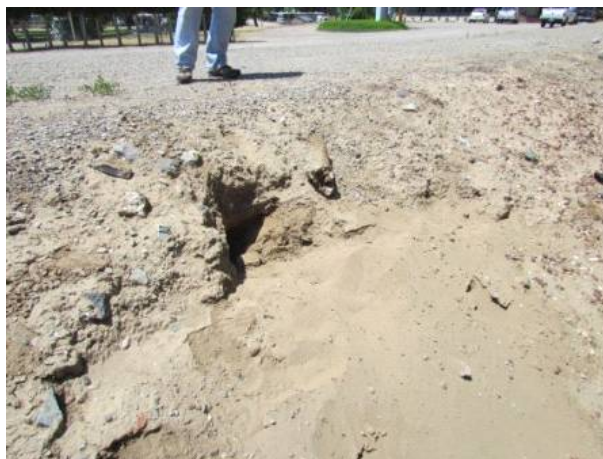
mkhashch_s_20120525_406.jpg

Levee Mile Report Line	5
Start Levee Mile	0.08
End Levee Mile	0.08
Location	Land Side
Category	Earthen Levee
Item	Animal Control

View of large burrow hole in landside slope. Grout plug did not work as it was removed by squirrels and is visible next to the hole on the right.
05/24/2012

LMR No.	Levee Mile		Category	Item	* Location	** Rating	Action/Comment	GPS Latitude/Longitude		Issue No. Photo
	Start	End						Start	End	
1			Earthen Levee	Operations & Maintenance Manuals	WS	A Ma		°	°	1
DWR ID: DWR_RD2096_01_s_2012_1										
2			Earthen Levee	Emergency Supplies & Equipment	WS	A Ma		°	°	2
DWR ID: DWR_RD2096_01_s_2012_2										
3			Earthen Levee	Flood Preparedness & Training	WS	A Ma		°	°	4
DWR ID: DWR_RD2096_01_s_2012_4										
4	0.04	0.17	Earthen Levee	Encroachments	LS	M En	FE : Fences Inspector Comments: Fence at toe of levee obstructs access.	37.773495 ° -121.298411 °	37.772722 ° -121.298436 °	3 Y
DWR ID: DWR_RD2096_01_s_2012_3										
5	0.08	0.08	Earthen Levee	Animal Control	LS	M Ma	A1 : Exterminate rodents and backfill and compact or grout burrows.	37.773048 ° -121.298390 °	37.773048 ° -121.298390 °	6 Y
DWR ID: DWR_RD2096_01_s_2012_6										
6	0.12	0.12	Earthen Levee	Animal Control	WS	U Ma	A1 : Exterminate rodents and backfill and compact or grout burrows.	37.772485 ° -121.298463 °	37.772485 ° -121.298463 °	5 Y

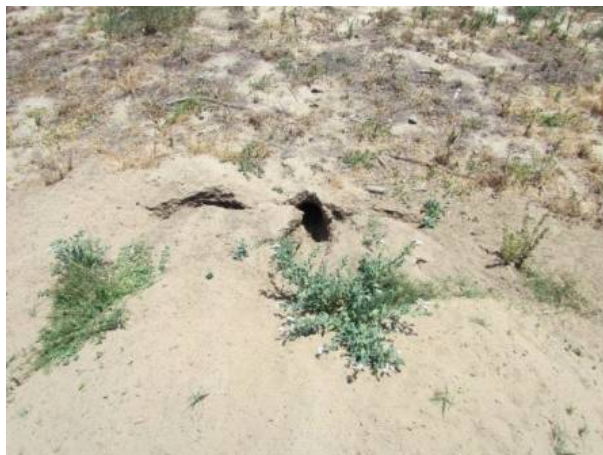
mkhashch_s_20120525_404.jpg

Levee Mile Report Line	6
Start Levee Mile	0.12
End Levee Mile	0.12
Location	Water Side
Category	Earthen Levee
Item	Animal Control

View of large burrow holes at waterside toe.
05/24/2012

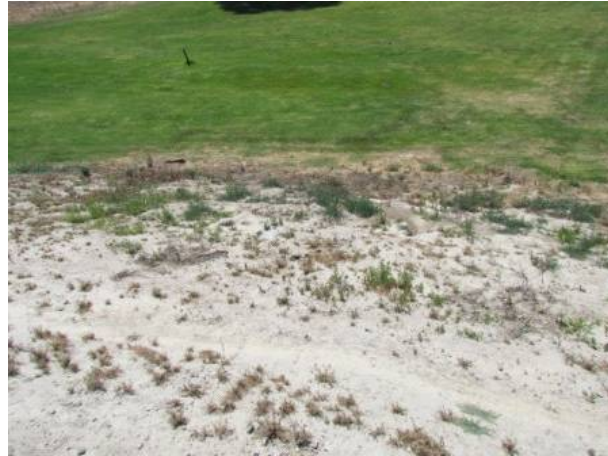
mkhashch_s_20120525_405.jpg

Levee Mile Report Line	6
Start Levee Mile	0.12
End Levee Mile	0.12
Location	Water Side
Category	Earthen Levee
Item	Animal Control

View of active burrow holes at waterside toe.
05/24/2012
